**DEVELOPMENT OF HIGH TEMPERATURE  
ALKALI METAL RESISTANT INSULATED WIRE**

**3rd Quarterly Progress Report  
Contract AF33(657)10701, Task No. 8128-08**

**Westinghouse Electric Corporation  
Aerospace Electrical Division  
Lima, Ohio**

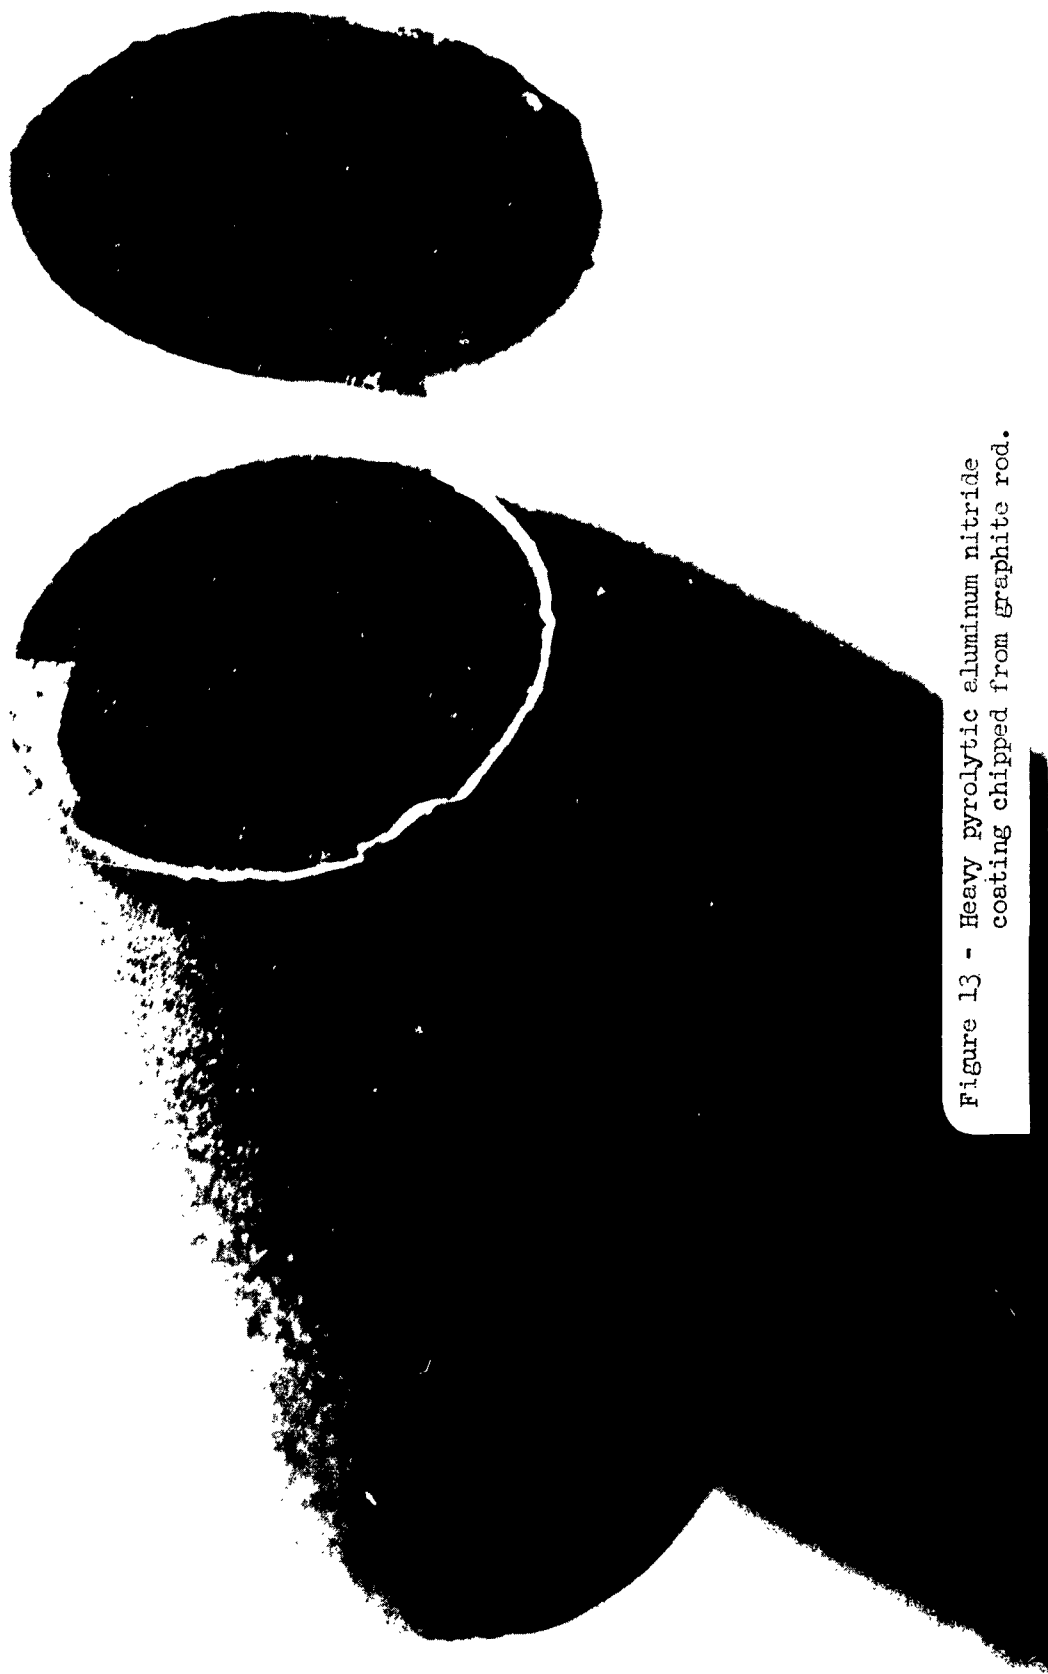
Figure 13 - Heavy pyrolytic aluminum nitride  
coating chipped from graphite rod.

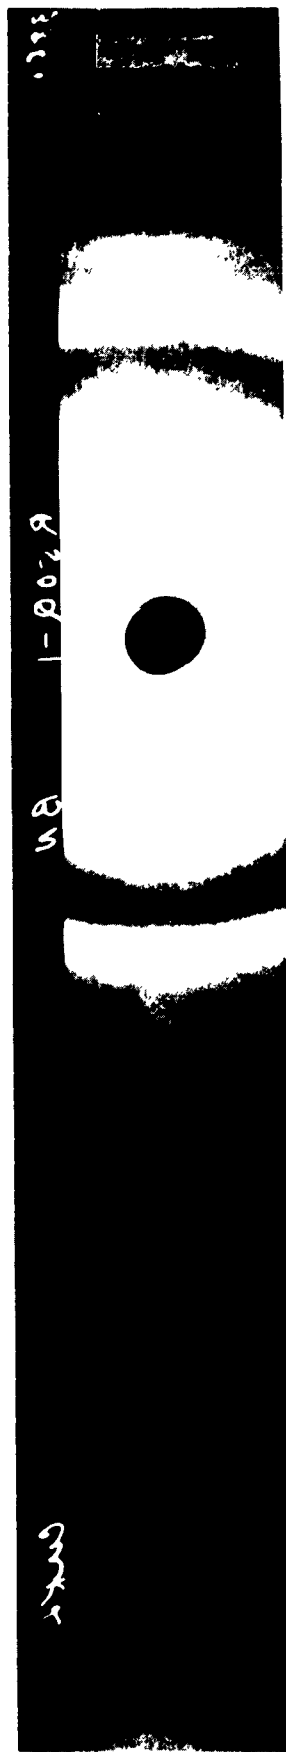
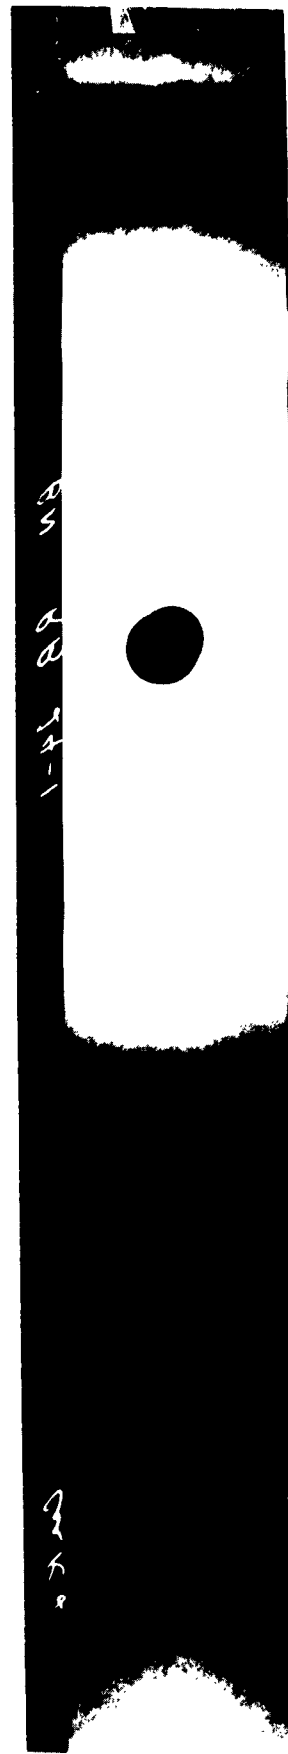
Figure 24 - X-ray Diffraction Patterns for Deposited Films

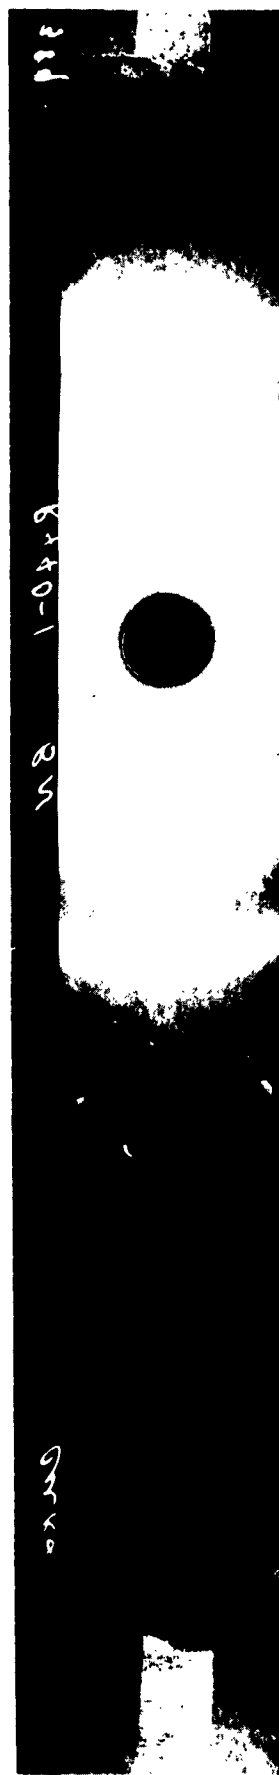
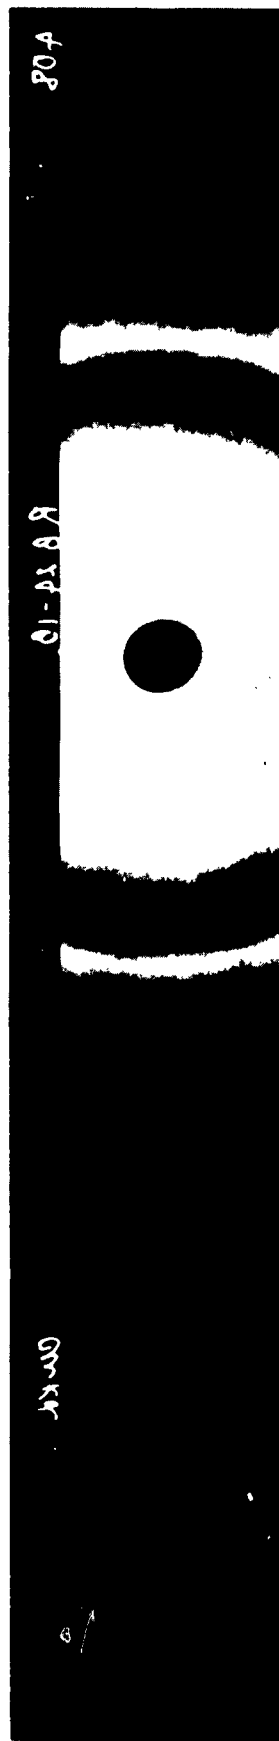
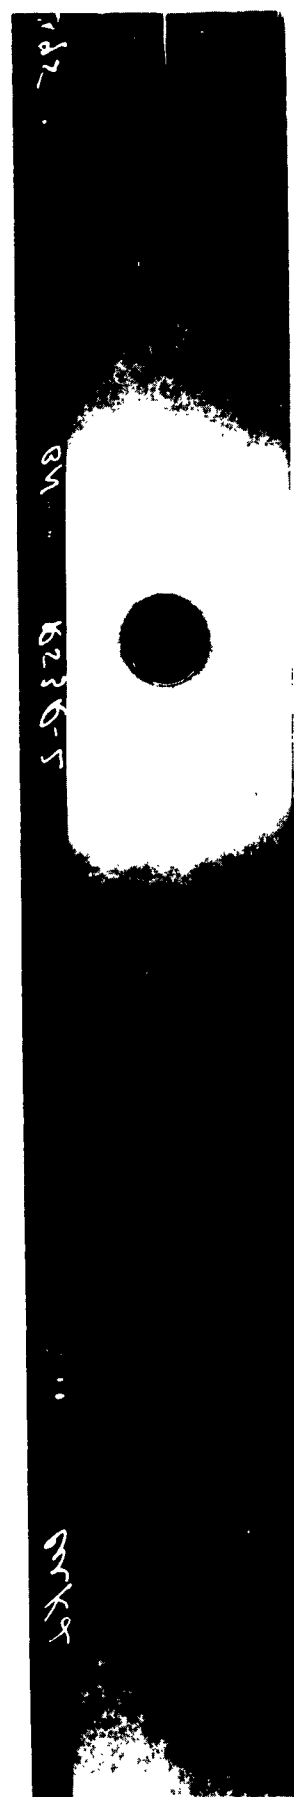
R 53 - 2

Figure 25 - X-ray Diffraction Patterns for Deposited Films

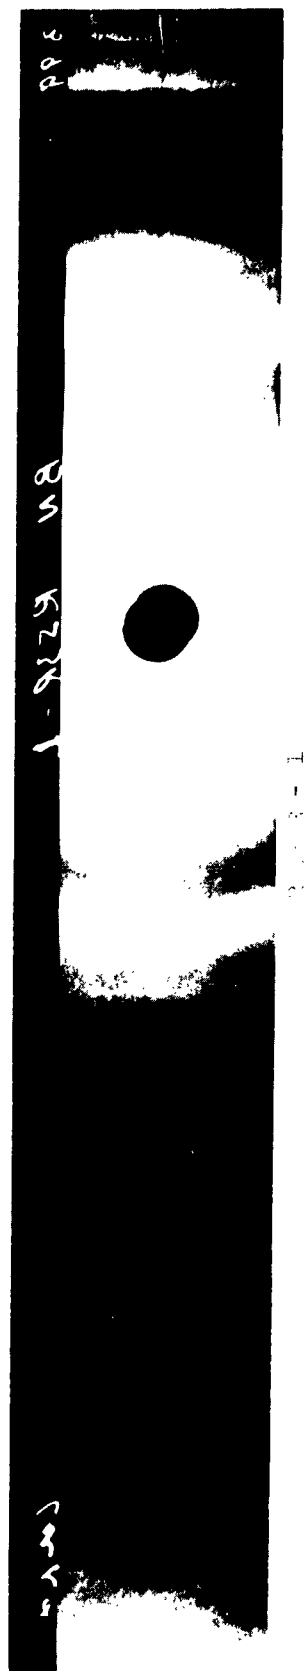
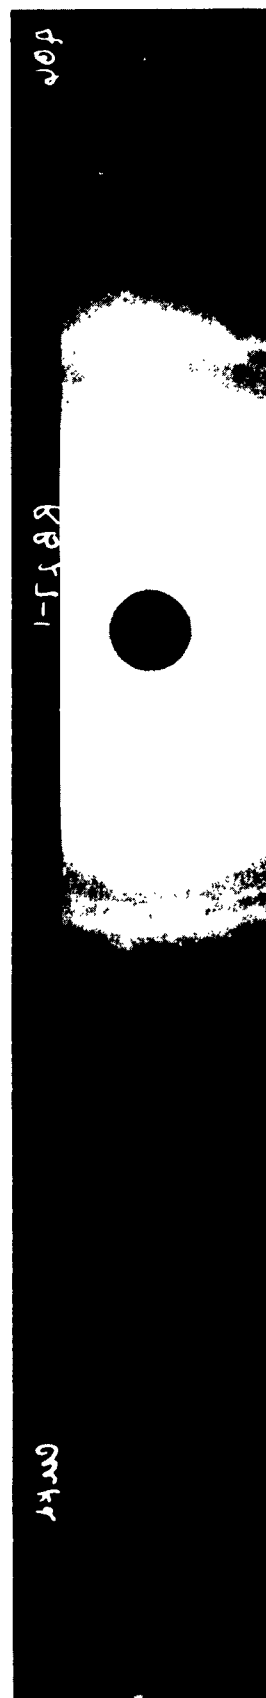
RB 27 - 1

Figure 27 - X-ray Diffraction Patterns for Deposited Films
